**Serious Injury Collision, St Vincents Road, Banyo
14 September 2012**

Final report, rail incident investigation TMR 4617

Major rail incident investigation

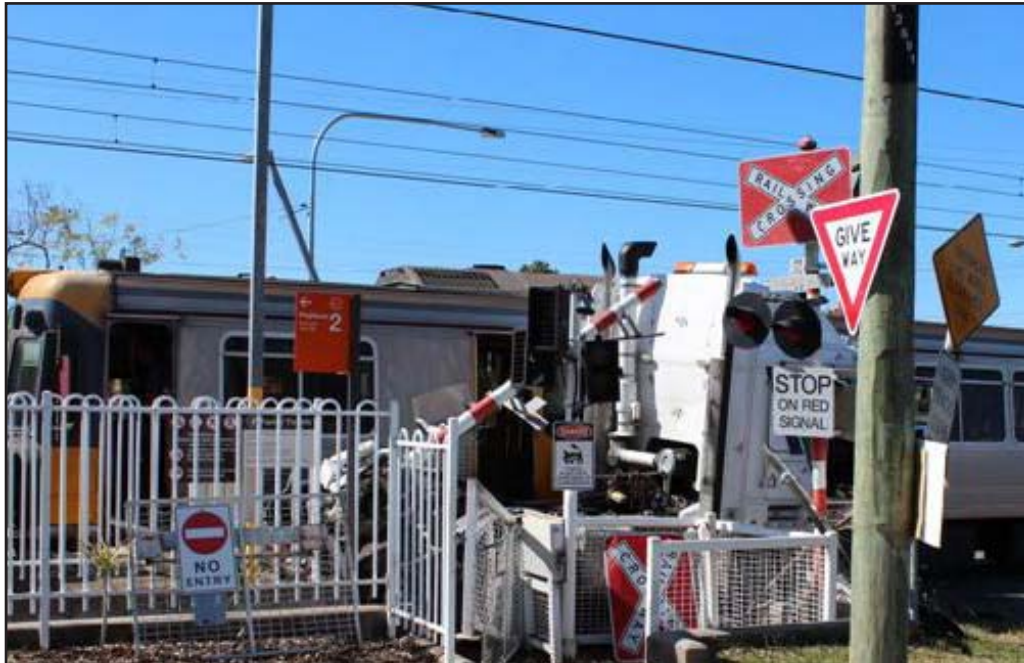
Figure 6: Damage to rail infrastructure

The pedestrian and level crossing protection equipment sustained extensive damage, as shown in Figure 6. The rail infrastructure including tracks and support structures and the overhead electrical lines sustained minor damage.

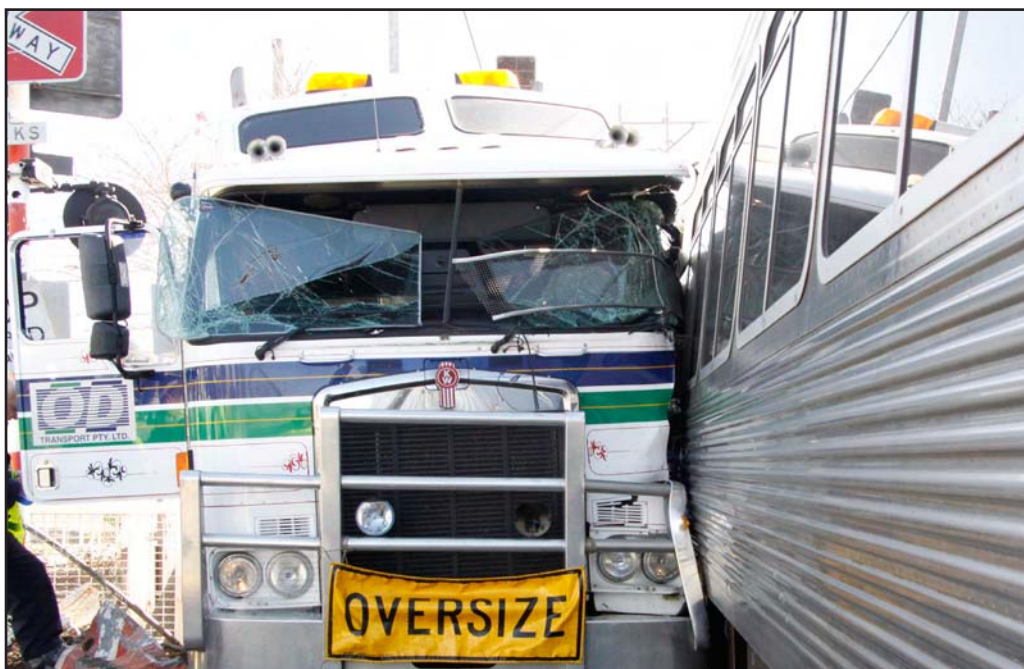
Figure 7: Damage to heavy vehicle

The heavy vehicle sustained extensive damage, as shown in Figure 7.

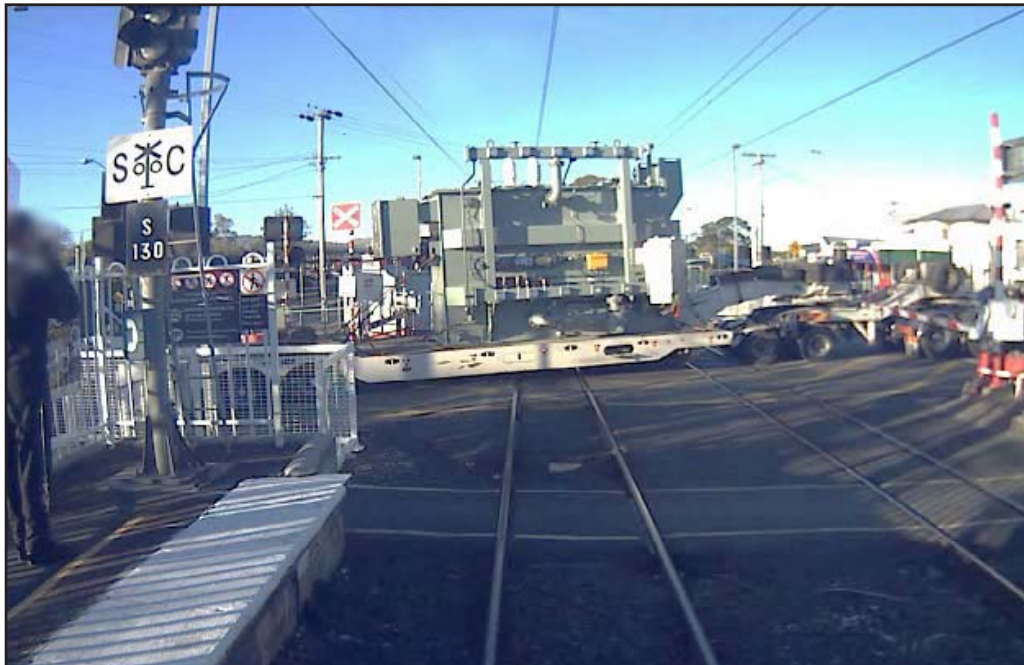
The CSA was located on the western platform at this time and observed the heavy vehicle become grounded on the crossing. The CSA ran back to the eastern platform where the station office is located to obtain a radio. As the CSA was returning to the station office, the driver of the heavy vehicle exited the cab.

Figure 8: Heavy vehicle grounded on the level crossing, the CSA to the left on the radio
